Phase I Environmental Site Assessment Report
Security Square Mall
6901 Security Blvd, Baltimore MD, 21224
Baltimore County Owned Parcels

Baltimore County Department of Planning
105 West Chesapeake Avenue
Towson, MD 21204

EA Engineering, Science, Technology, Inc., PBC
225 Schilling Circle, Suite 400
Hunt Valley, Maryland 21031
410-584-7000

EA Project No. 16424-04
1 October 2025

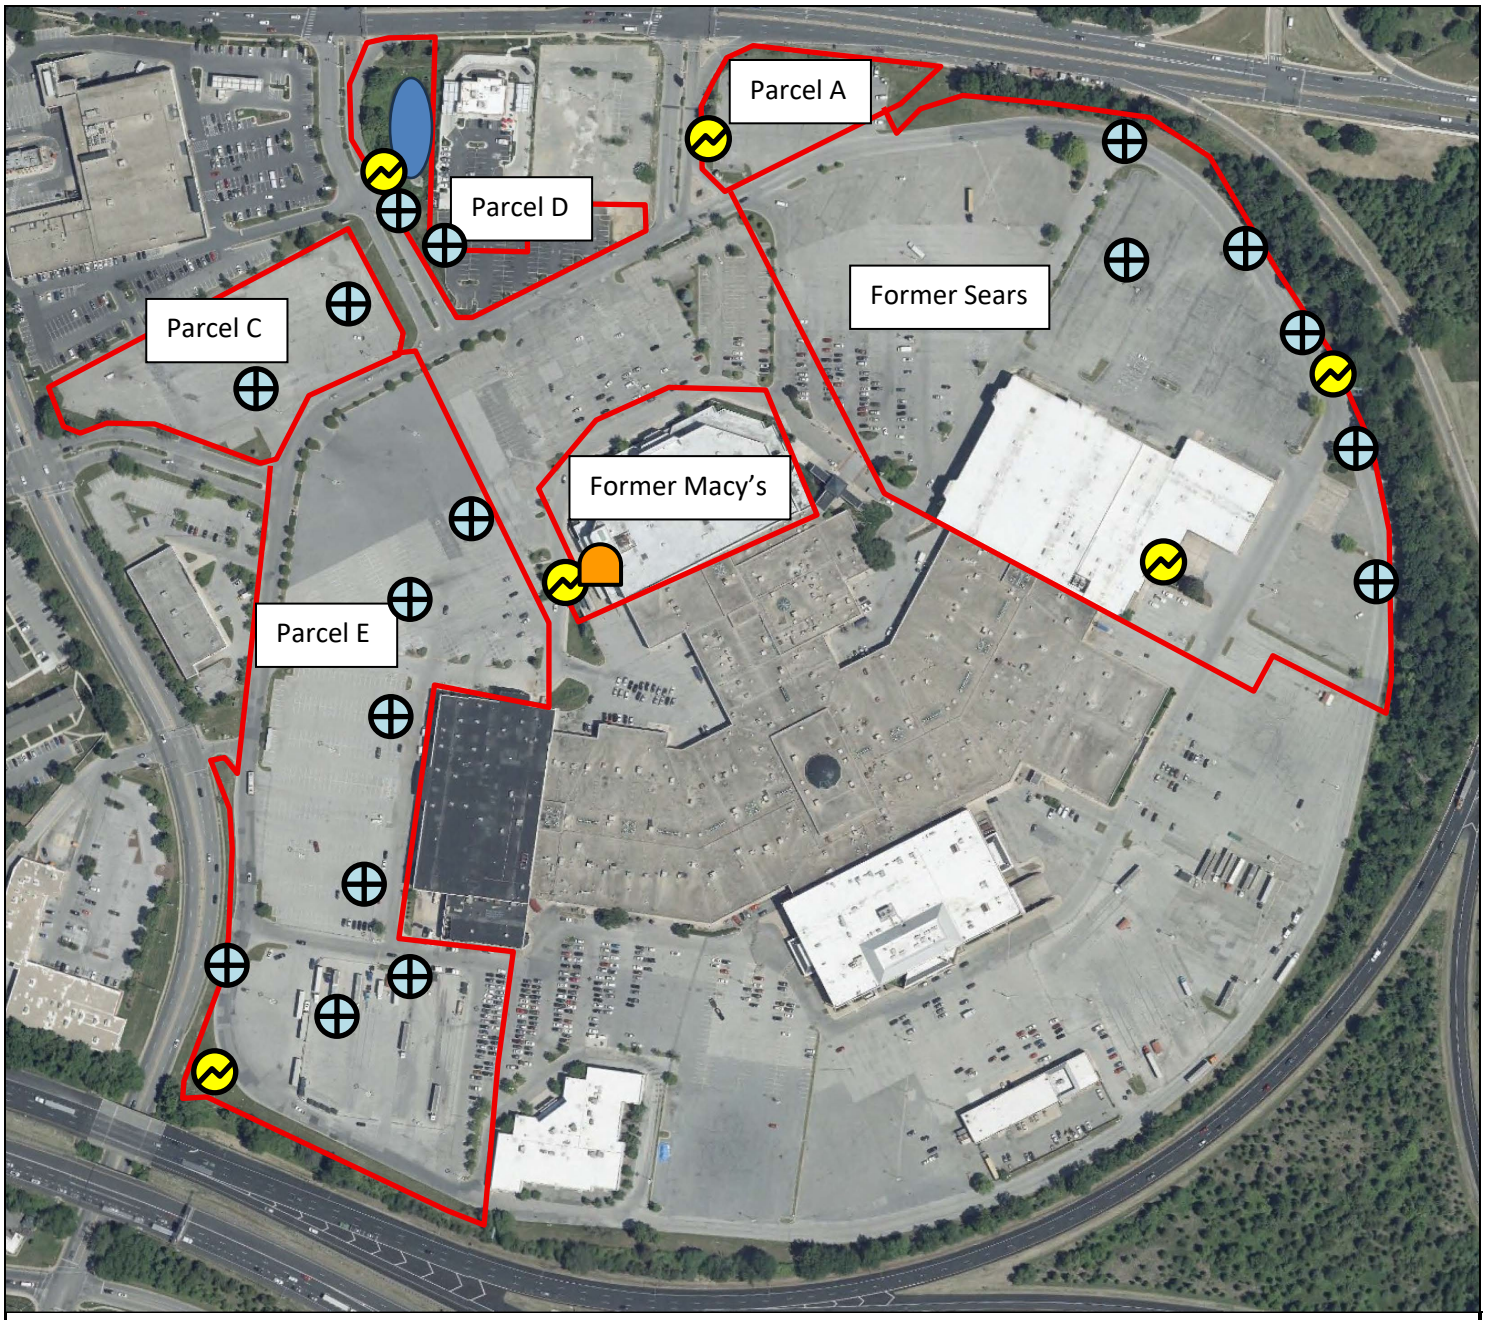
Elevator control room - leak

Emergency Generator (top floor) – leak

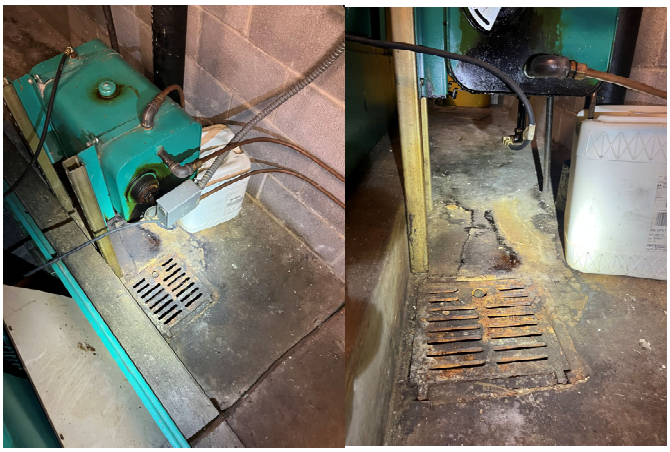
- Leaking emergency generator fuel tank – An emergency generator was observed in the mezzanine level of the Former Macy's. The day tank attached to the generator was actively leaking diesel fuel into a floor drain located beneath the fuel tank. The discharge point of the floor drain is unknown. The presence of the active oil leak constitutes a REC for the Subject Property.

Photo 20: Oil leaking from tank of emergency generator into floor drain, mechanical room

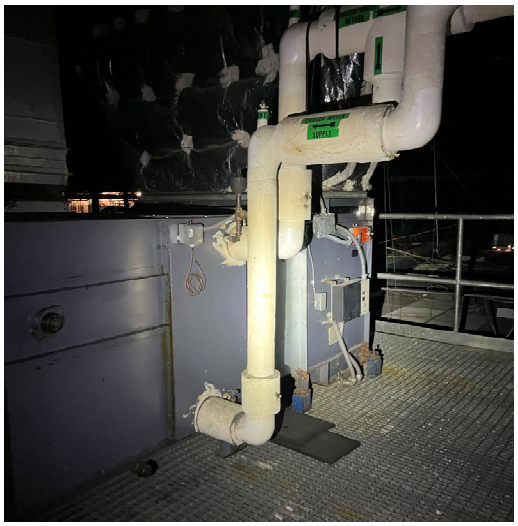
Photo 22: Top floor AC piping

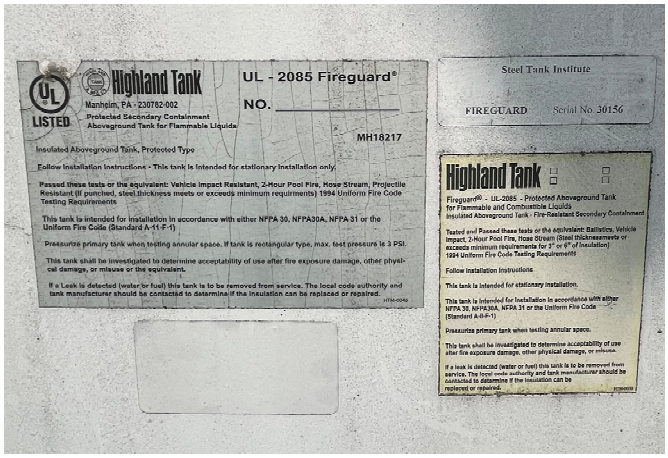
Photo 26: AST label

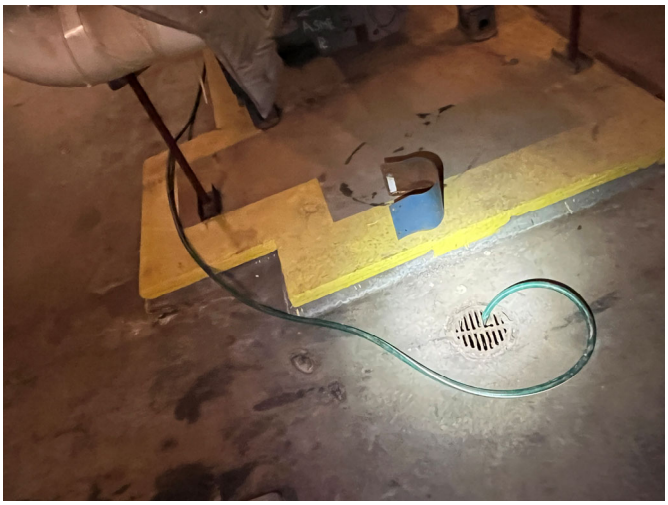
Photo 16: Floor drain second floor mechanical room

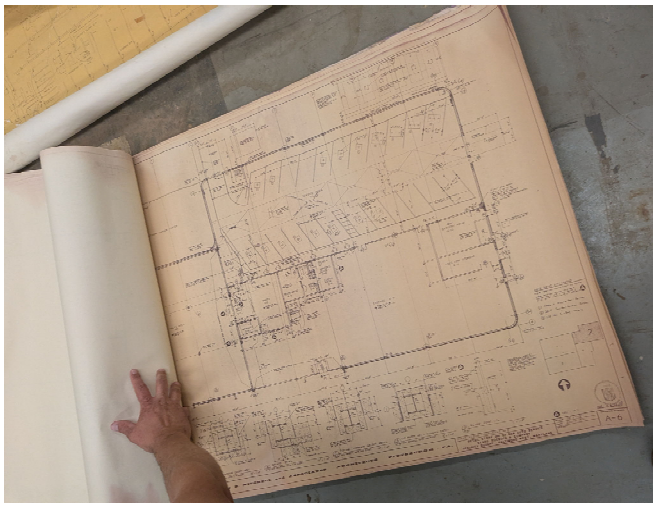
Photo 29: Planning documents overview

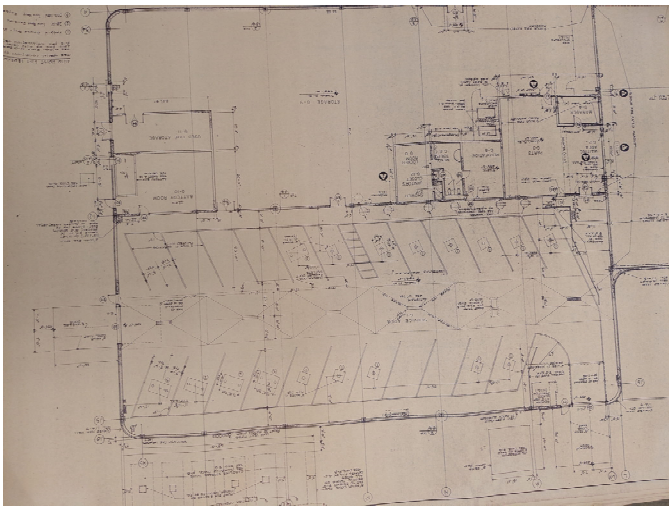
Photo 30: Sears auto service center in planning documents

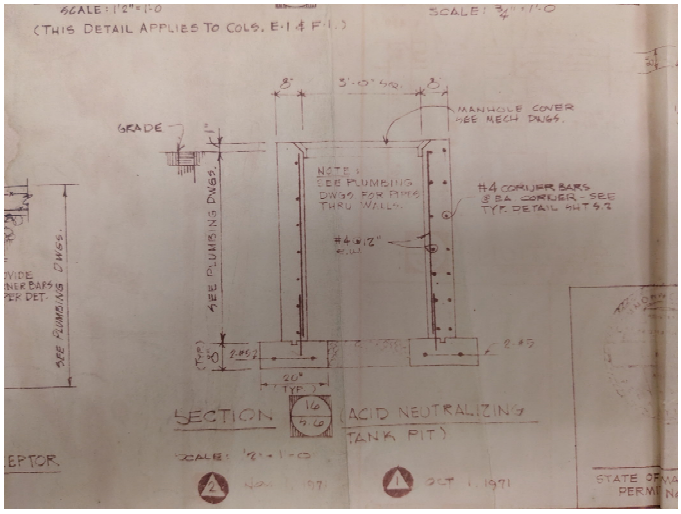
- Acid Neutralization Pit - An underground Acid Neutralization Pit associated with the Former Sear's Auto Service Center was observed outside the Battery Storage Room door during the site reconnaissance. The current condition of the pit is unknown and the historic operation of the pit represents a potential pathway for hazardous substances to be released to the environment, constituting a REC for the Subject Property.

Photo 31: Acid neutralization pit in planning documents

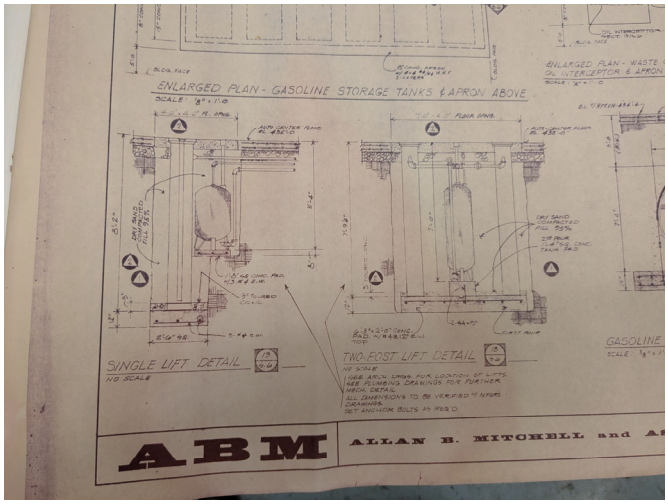
- Hydraulic systems – Evidence of multiple hydraulic systems was observed in the garage of the Former Sears Auto Service Center. A review of historical documents observed in the mechanical room during the site reconnaissance depicted thirteen single-acting and five double-acting hydraulic systems installed in the building. Visual evidence that several systems remain in place was also observed during the site reconnaissance. The status and condition of the systems beneath the concrete floor is unknown. Additional systems may be hidden from view due to the current use of the garage as storage for Baltimore County. Hydraulic systems may contain hazardous substances and/or petroleum products, and the potential for a system leak constitutes a REC for the Subject Property.

Photo 32: Hydraulic systems in planning documents

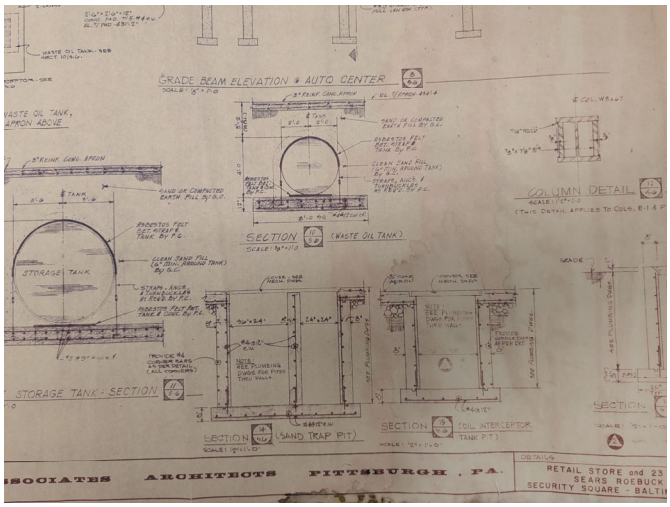
- Sand trap – A sand trap and five floor drains were observed in the floor of the Former Sear's Auto Service Center garage area during the site reconnaissance. The current condition of the trap and drains is unknown and the former use of the drainage system represents a potential pathway for hazardous substances or petroleum products to be released to the environment, constituting a REC for the Subject Property.

- Waste Oil UST – According to a report provided by BCDEPS, a 550-gallon steel UST containing waste oil was removed in 1993. The report indicates perforations were observed on the tank and the surrounding soil was contaminated. It is unknown if the contaminated soil has been addressed. The potential presence of contaminated soil constitutes a REC for the Subject Property.

Photo 33: Waste oil tank and sand trap in planning documents

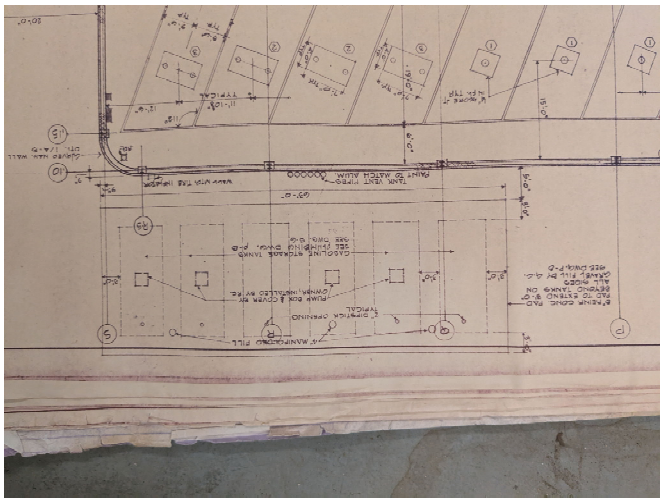
- USTs – Architectural Plans dated 1971 were reviewed for the former Sears Auto Service Center was observed during the site reconnaissance showing the installation of six 5,000-gallon gasoline USTs. In addition, records contained in the EDR Report as well as provided by Baltimore County indicate that six 5,000-gallon gasoline USTs were removed in 1986. Aerial photographs show that a concrete pad in the suspected location of the USTs was replaced with asphalt between 1982 and 1988. No additional information regarding the removal of these USTs was provided by MDE. The potential of environmental impact cannot be ruled out, constituting a REC for the Subject Property.

Photo 34: 5,000-gallon Gasoline USTs location in planning documents
